Partial Discharge and Associated Mechanisms for Micro for Micro Gap Delamination at GIS Spacer

Abstract: Partial Discharge (PD) measurements are very promising for insulation condition monitoring in Gas Insulated Switchgears (GISs). However, for accurate PD detection and diagnosis, there is a need for better understanding of physical mechanisms behind PD activity. Accordingly, the PD characteristics and associated mechanisms for electrode/epoxy delamination of GIS spacers have been investigated as one of the severest defects in GIS. The most important mechanism affecting PD activity at delamination is the surface charge accumulation on the epoxy surface.

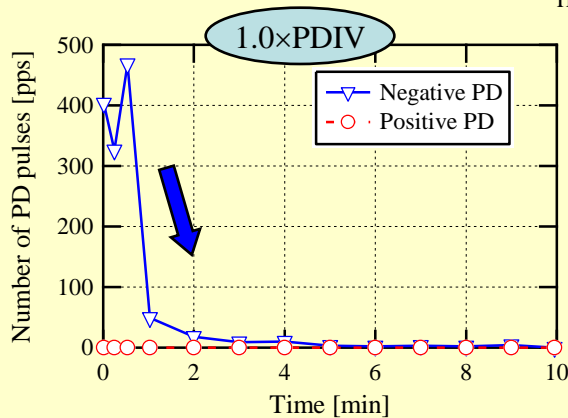
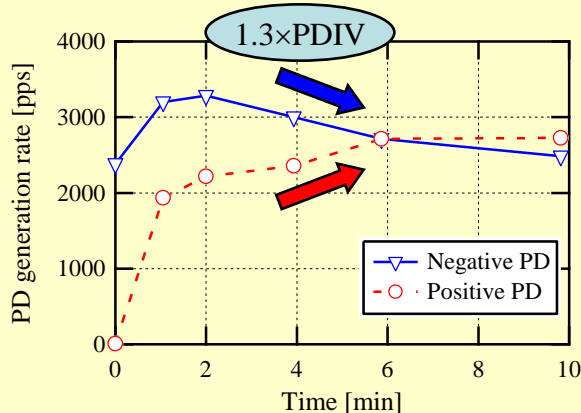
Effects of charge accumulation on PD activity

(b) After 10 minutes of voltage application ($V_a = 1.3 \times \text{PDIV}$)
